# State of the Watershed

## Water Quality Report for the Clackamas River Basin

Spring 2016

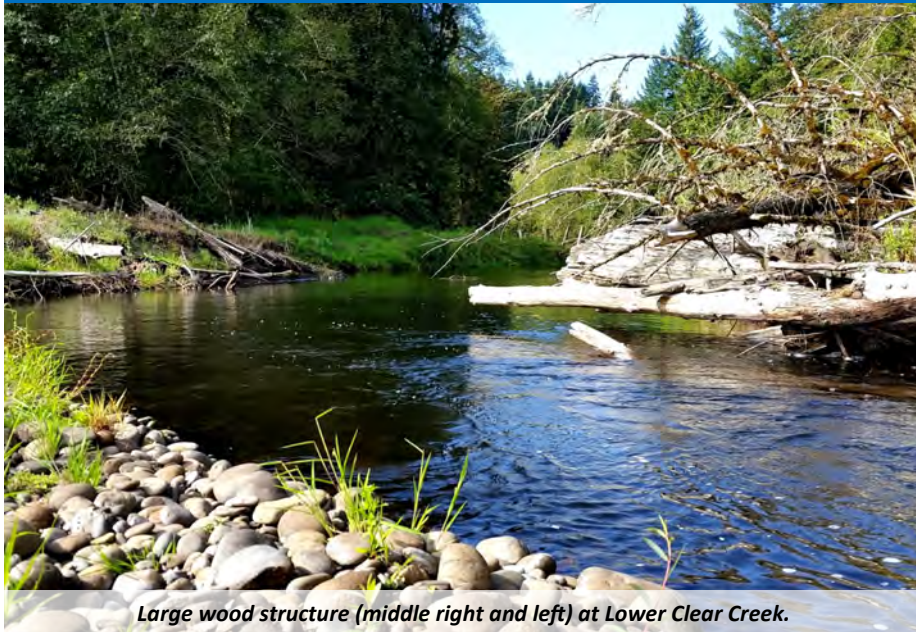
# Lower Clear Creek at Metro Property

*Large wood structure (middle right and left) at Lower Clear Creek.*

over 100 projects across the Clackamas watershed. In addition, an OWEB grant made construction at this site possible as multiple log jams were placed in 3 different areas along Clear Creek and in a backwater channel using 191 logs and 345 boulders. This added roughness to a stretch of Clear Creek that was previously limited, which helps slow high water flows and provides important refuge for young fish during flood events. Water quality data collected at this site was obtained after both in-stream construction and a majority of the revegetation activities, though more planting has taken place since fall of 2014. Overall, Lower Clear Creek had good readings for pH, conductivity, and turbidity which were all within the standard benchmarks. Dissolved oxygen and RBS were not too far off the mark either. However, this site's sparse canopy cover, wide floodplain, and low summer flows likely contributed to warm water temperatures that did not meet requirements for spawning salmon during September sampling. The last several dry summers in Oregon have also been more extreme and extended in recent years. Timing may also be contributing to a disturbed macroinvertebrate community as sampling occurred during a transition from one season to the other and may have caught populations in-between changing lifecycle stages. Furthermore, Clear Creek is surrounded predominately by agricultural lands, most of which are Christmas tree and rural farms. These land uses can contribute to increased nutrient levels. In general, Clear Creek water quality is typically in better condition than in other lower basin watersheds and as such is a priority for maintaining coho, Chinook, and steelhead populations. In addition to CRBC's work

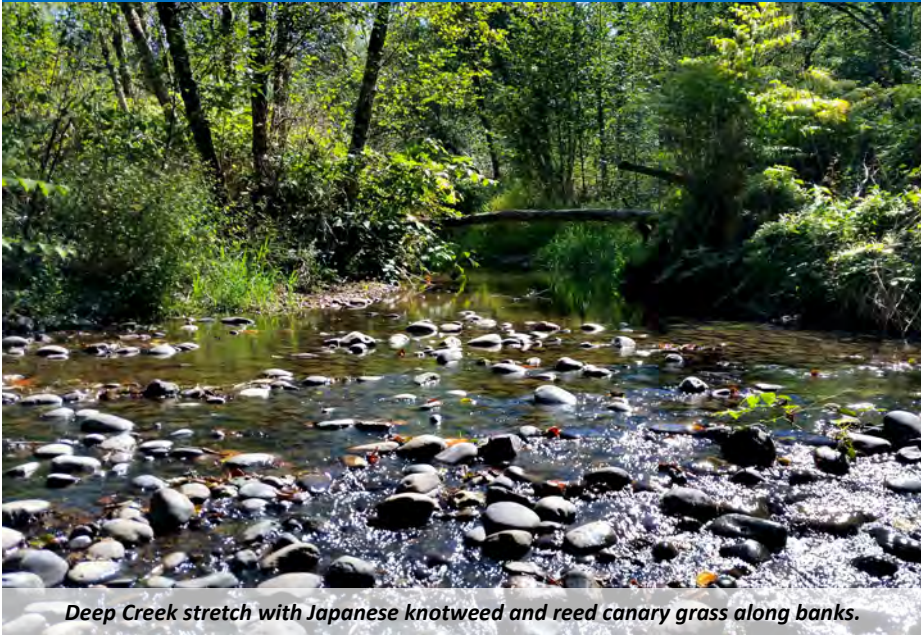
# Deep Creek along Judd Road

Deep Creek stretch with Japanese knotweed and reed canary grass along banks.

Overall, Deep Creek had the best macroinvertebrate assessment with the most mayfly and stonefly richness (i.e. count) and was classified as moderately disturbed instead of most disturbed or severely impaired like the other sites. As seen in the photo above, there is plenty of riffle and cobble habitat. Warm water temperatures at this time of year and pollutant inputs are most likely influencing macroinvertebrate populations.

aggressively downstream by way of water. This site is no exception with nearly 2 acres that needed to be treated for invasive species including knotweed. By tackling 11 acres of contiguous streamside properties, CRBC is much more effective in knocking back infestations by treating long stretches and involving entire neighborhoods in the process. Both coho salmon and steelhead use over 30 miles of stream in the Deep Creek subbasin for rearing and spawning, which is why it's so important to remove these monocultures of weeds and replace them with shade producing natives such as Douglas fir, cottonwood, and Western red cedar, keeping the water cool for these temperature sensitive species.

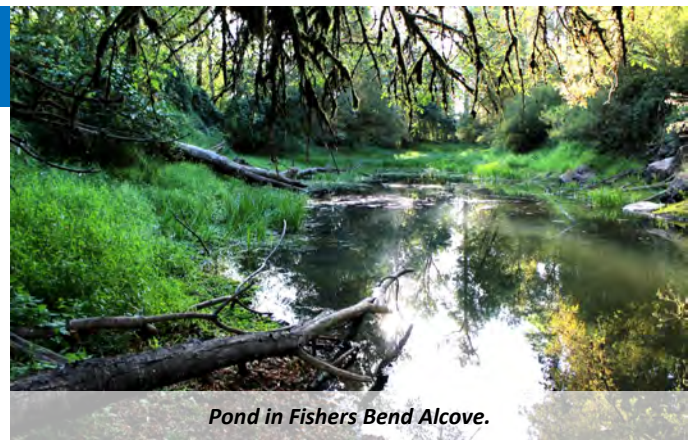
Pond in Fishers Bend Alcove.

Water quality data collected at this site was gathered prior to restoration activities in order to have baseline data and observe changes over time. As seen in Figure 2, a number of water quality parameters were found to have poor or fair readings including temperature, dissolved oxygen, conductivity, and relative bed stability. None of these were surprising, given that prior to construction and restoration activities at this site, Fishers Bend was a pond — with stagnant water. This means less flowing water and increased surface area for sunlight to warm water temperatures and decrease dissolved oxygen. These conditions are detrimental to healthy macroinvertebrate populations and are also ripe for algae growth. With a silty substrate, absence of cobble, a lack of roughness (i.e. large woody debris) and vegetation in the floodplain, it also creates opportunity for erosion of

sediment indicated by the RBS and turbidity values. This site is also influenced by its close proximity to the highway. While water quality parameters and macroinvertebrates were collected in pond habitat, the channel characteristics were measured in the dry stream channel. With the creation of a functioning alcove that reconnects the pond to the Clackamas River, these water quality parameters and habitat measurements should improve over time. Furthermore, anticipated future restoration during Phase II of the project is expected to reconnect the downstream alcove to another 2,350 feet of historic side channel and restore 4.5 acres of habitat. With these enhancements, Fishers Bend will provide key off-channel fish habitat and makes it an ideal site to promote restoration and conservation through educational opportunities. The Fishers Bend project was made possible with funding from the Oregon Wildlife Foundation, Oregon Watershed Enhancement Board, and the US Forest Service. Partner support includes Chrysalis Farms, Clackamas County Parks, Clackamas Soil & Water Conservation District, Oregon Department of Fish and Wildlife, and CRBC's Shade Our Streams program.

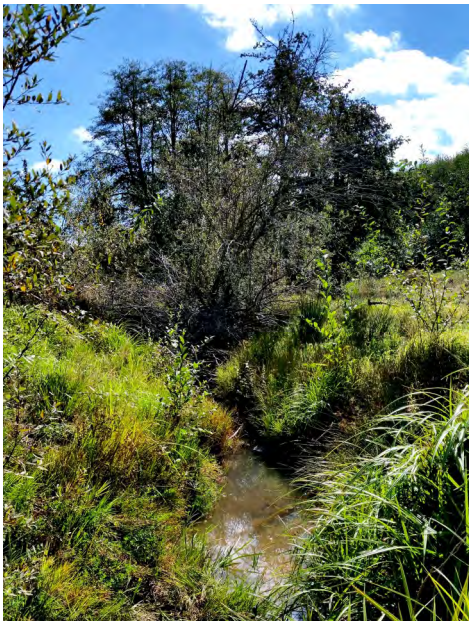
*Tickle Creek below pond at Sandy Bluff Park.*

Water quality at this site had the poorest readings of all sites sampled, with temperature, pH, and dissolved oxygen outside the optimal range. Tickle Creek also had the highest turbidity and RBS. Of note however, this portion of Tickle Creek is near the headwaters which originate beneath a shopping center located on the hillside. The creek is created from surface runoff and groundwater from this hill as well as the adjacent high school sports fields and agricultural lands. Tickle Creek flows into a pond and during periods of low water, the outlet is a dry channel bed before groundwater once again establishes flow downstream. This dry channel influenced some of the water quality and habitat readings. Additionally, the presence of beavers creates disturbance and can increase suspended solids, slow water flow, and thereby warm water temperatures and reduce available oxygen. The lack of tree canopy needed to provide shade at the site also contributes to these conditions and will continue to do so until the recent plantings can establish themselves in years to come. Of all 5 sites, Sandy Bluff Park had the worst macroinvertebrate results (as seen by species richness) with severe impairment due to its glide habitat (i.e. smooth water) and absence of cobbles and riffles.
