# The Clackamas Current

Newsletter of the Clackamas River Basin Council

Special Edition  
Summer 2014

## WATER IN THE WATERSHED

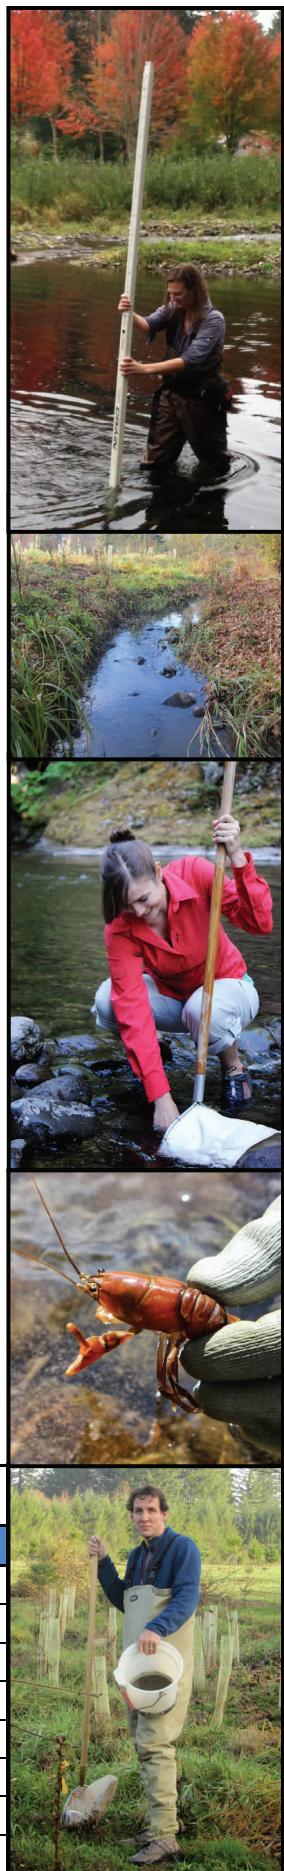
Benchmarks of tested parameters: **Good**, **Fair**, **Poor** - Interpretations determined using Oregon's water quality standards provided in DEQ's 2009 Willamette Basin Rivers and Streams Assessment (Mulvey, Leferink, and Borisenko).

Using a Thermo Orion Star multi-meter and HACH turbidimeter, water quality parameters including temperature, pH, dissolved oxygen, conductivity, and turbidity were measured as seen in Figure 1. Interpretations were determined using Oregon's water quality standards provided in DEQ's 2009 Willamette Basin Rivers and Streams Assessment (Mulvey, Leferink, and Borisenko) and DEQ's 2006 Willamette Basin TMDL: Clackamas Subbasin chapter.

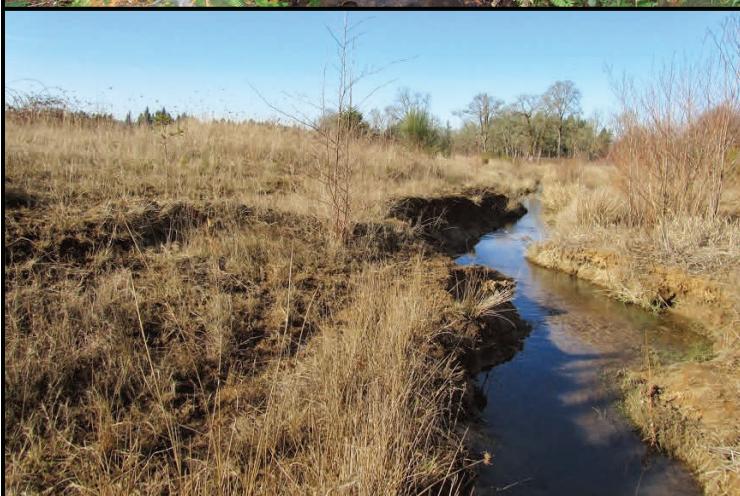
Photos: Examples of a healthy shaded riparian area (top) vs. unhealthy.

**Create more shade!** Removing invasive weeds along streams and replacing them with native plants can have far reaching effects for you and the stream. A riparian buffer of native grasses, rushes, shrubs, and trees provide food and shelter that improve water quality and create better habitat for plants, animals, and fish. As trees mature, their leaves create shade that will cool water temperatures which is critical for both drinking water and the health of many temperature-sensitive native fish species. The shade provided by native plants also lowers water temperatures and reduces the risk of algae growth. Planting a variety of trees and shrubs creates a network of roots that hold soil in place and reduce bank erosion. In addition, these plants help filter dirty water running off surrounding lands by trapping sediments and chemicals , preventing them from reaching the stream.
